## Case Study: Sprinkler System Check Valve Inspection for NFPA 25 Compliance

Company: Fire Protection Firm in WA State

Location: Tacoma, WA

Scope of Project: Inspected 12 check valves at a commercial residential complex

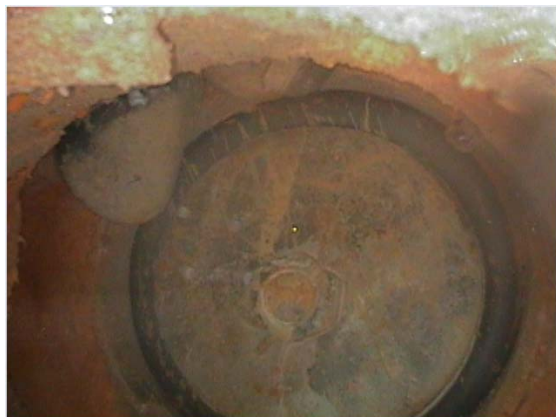
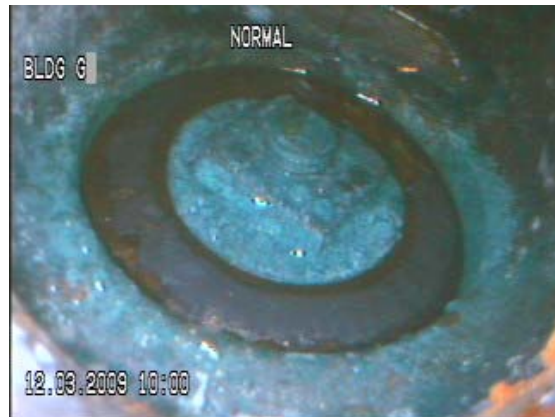
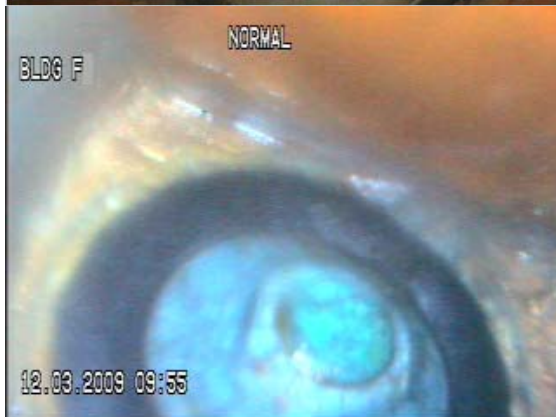
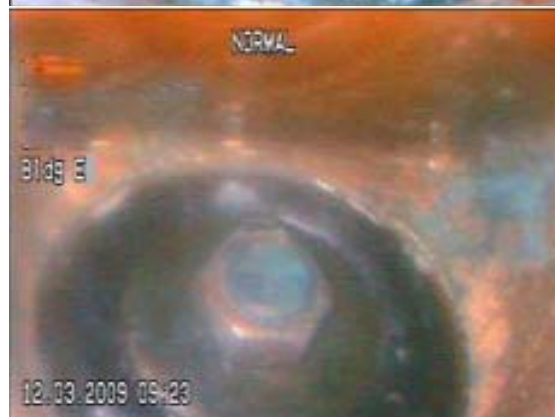
This inspection, while ultimately simple, poses serious technical challenges. Most sprinkler system pipes are only 2" internal diameter, and all have at least one 90 degree bend, most with 2 bends. Usually a technician must have both a video probe (6mm or 8mm diameter) as well as a small diameter push camera (1" to 2" diameter).

**Key Points:** All the check valves at the Tacoma location were in satisfactory condition and the customer was able to comply with NFPA 25 using remote visual inspection which avoided the significant cost of excavating the valves. Inspection was completed in 3 hours.
